## STORAGE

## COATINGS AND SEALING

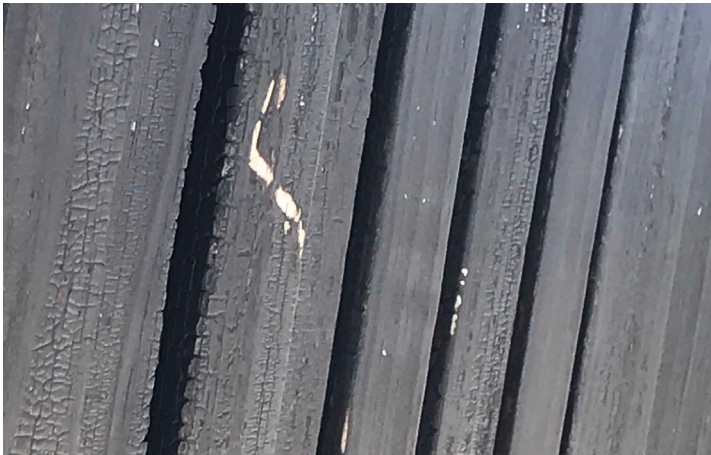
### Affected area

Scorching of any timber surface is a violent process and therefore the end result whilst somewhat predictable can also lead to some unintended consequences not predictable by M&B at the time of production. One of these is that after installation some small sections of the scorched surface may dislodge from the solid timber beneath as shown in the picture below. Where this occurs this will not affect the overall performance of the timber in any way as long as it is corrected at the next maintenance period.

If at any stage after installation this occurs there are some fairly simple rectification methods to return the product to an even surface appearance such as,

Simply re-coat the affected area with WOCA Exterior water based oil (black) and allow to dry. Repeat this until the desired colour is achieved to match the surrounding colour.

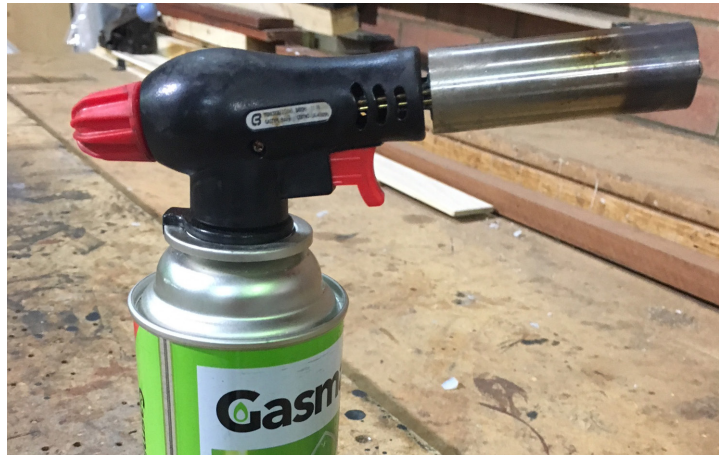
### Butane burner

By using a small hand held butane burner as shown above the affected area can simply be re-scorched to give the same surface appearance as surrounding material. After re-scorching the affected area, re-coating is required.
